### SERVICE BULLETIN

### BO208-SB-002/2025

Inspection Rudder Drive

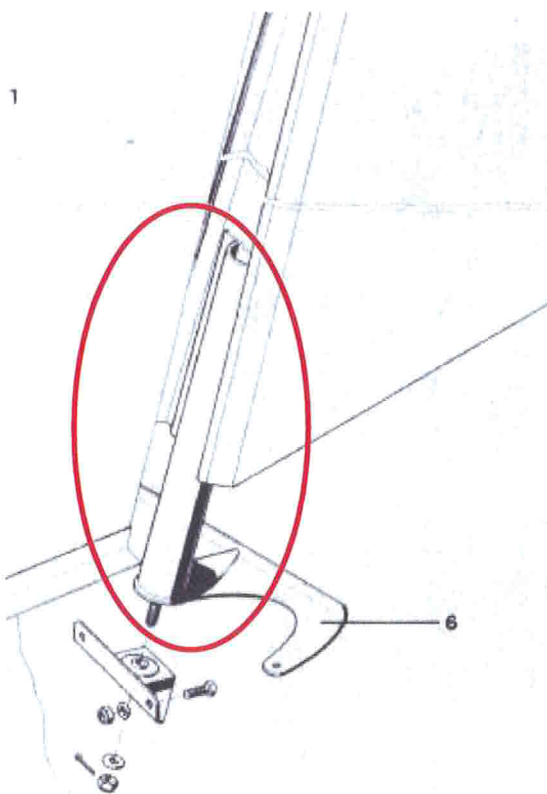
Abb. 1 / Fig. 1

Incidents involving corrosion of the rudder drive on Bo209 have been reported, and in one case, the drive tube failed. Due to the similarity of the design, the measures are extended to Bo208.

2. Inspect the inside of the torsion tube of the rudder drive (P/N 208-31014, see Fig. 1) for corrosion using an endoscope. Check the drainage hole at the bottom end next to the hinge pin for blockage and clean it if necessary.
3. If corrosion is found:  
Replace the rudder drive with a corrosion-free part. If a new component is required, it can be purchased from Wolf Hirth GmbH, Neue Strasse 107, 73230 Kirchheim unter Teck, Germany. Repair of the corroded component is not possible.
4. If no corrosion is found:  
The existing rudder drive can continue to be used.
5. Apply LPS 3® corrosion inhibitor to the inside of the rudder drive.
6. The drainage hole at the bottom end next to the hinge pin must then be checked again for blockage and cleaned if necessary.
7. Install the rudder according to the maintenance manual.
